US EPA ARCHIVE DOCUMENT

Final Report

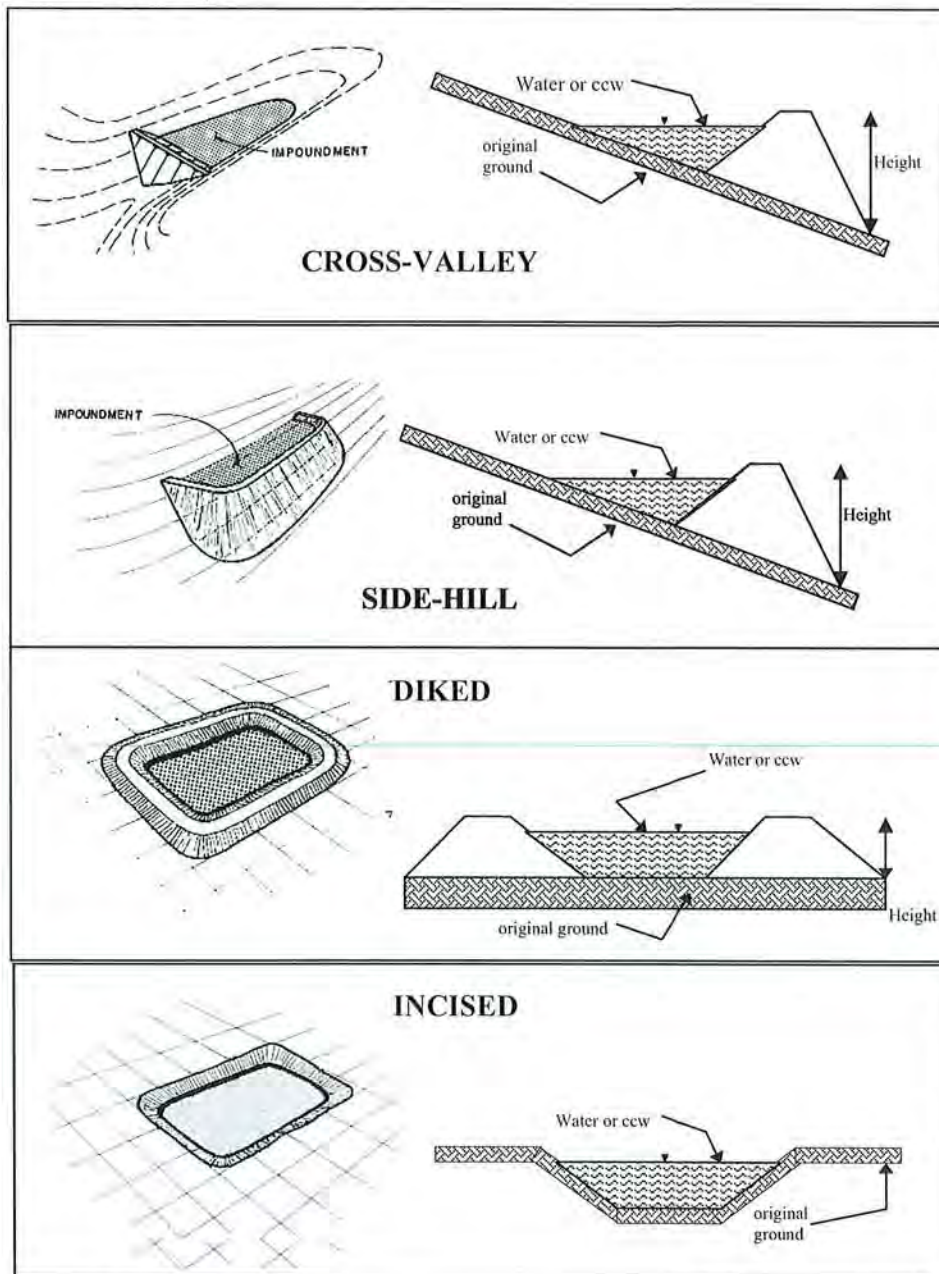
- ☐ Cross-Valley
☒ Side-Hill
☐ Diked
☐ Incised (form completion optional)
☐ Combination Incised/Diked

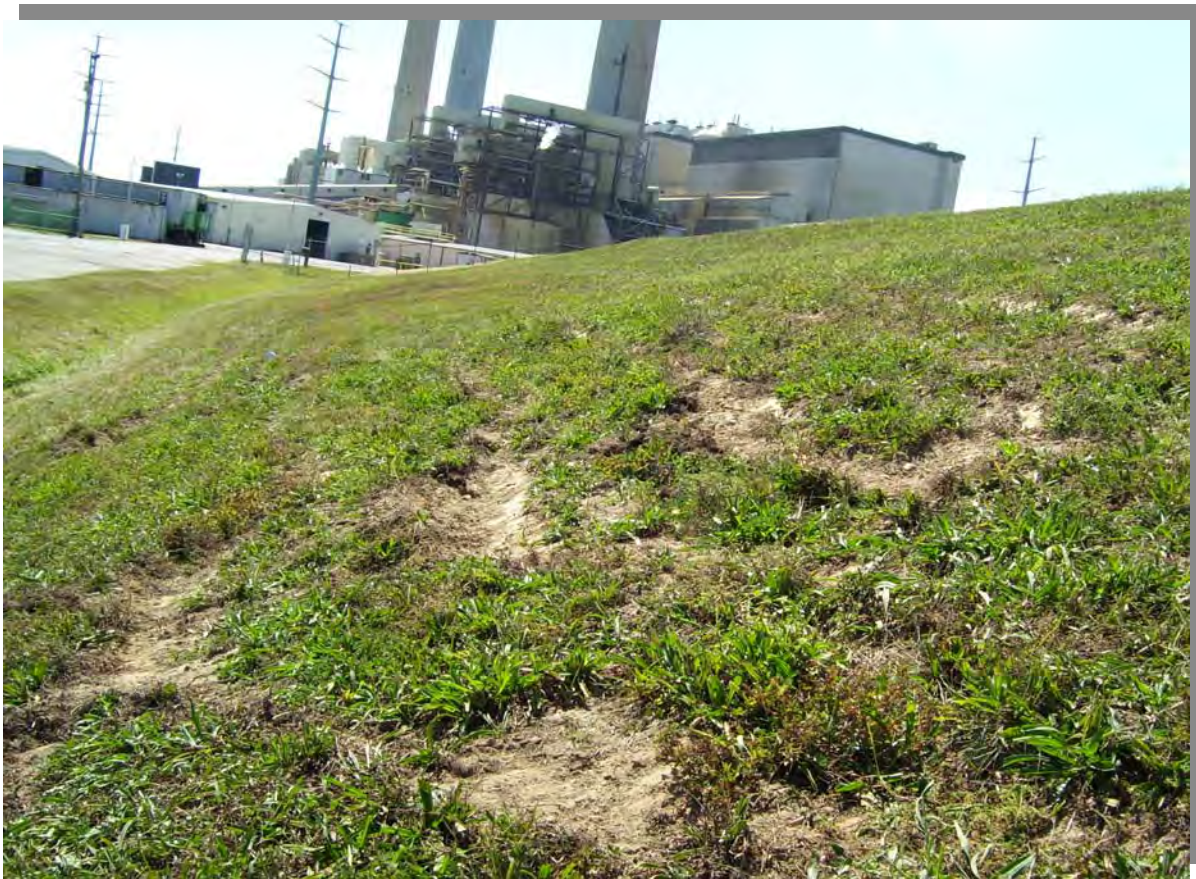
Photo 1 – View along eastern outboard slope looking south. Note rutting caused by mower/tractor.

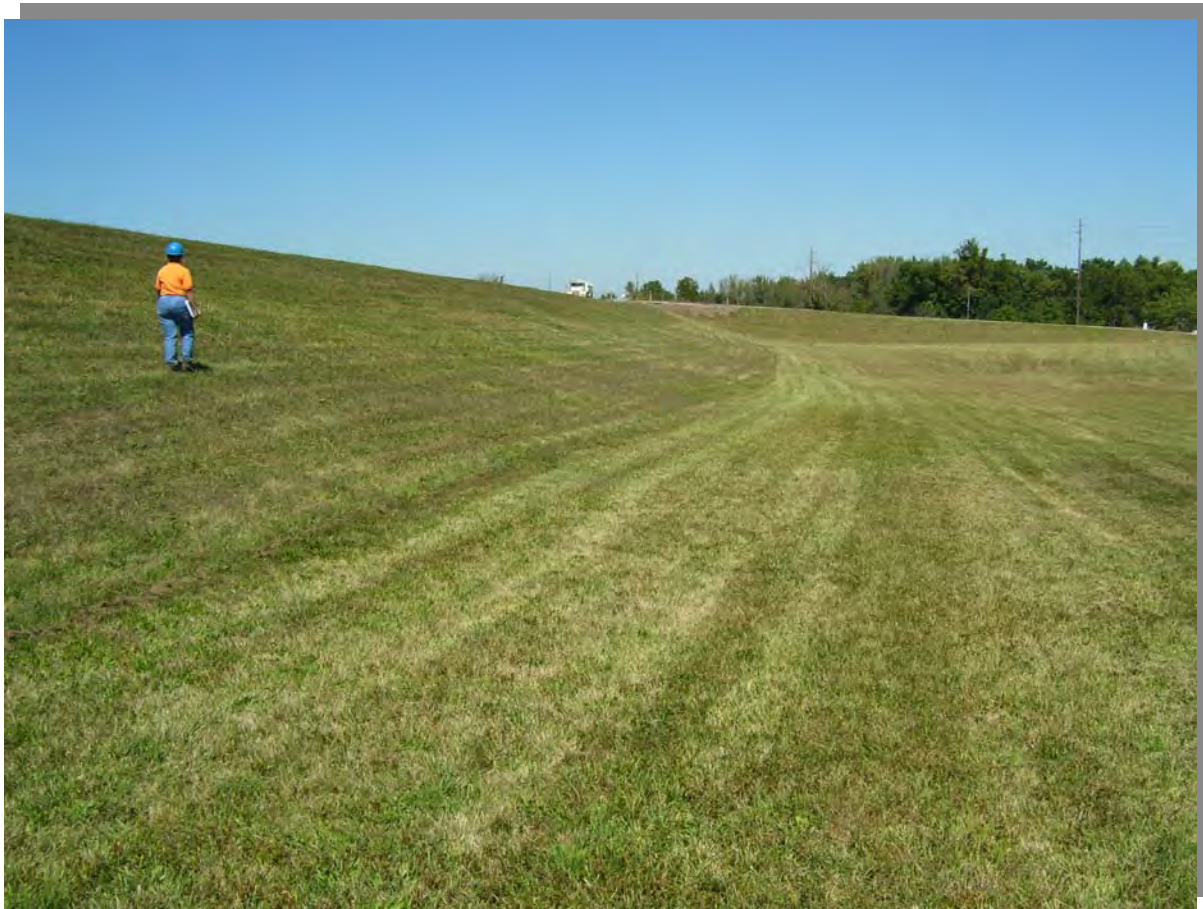
Photo 2 – View along 3H:1V eastern outboard slope looking north.

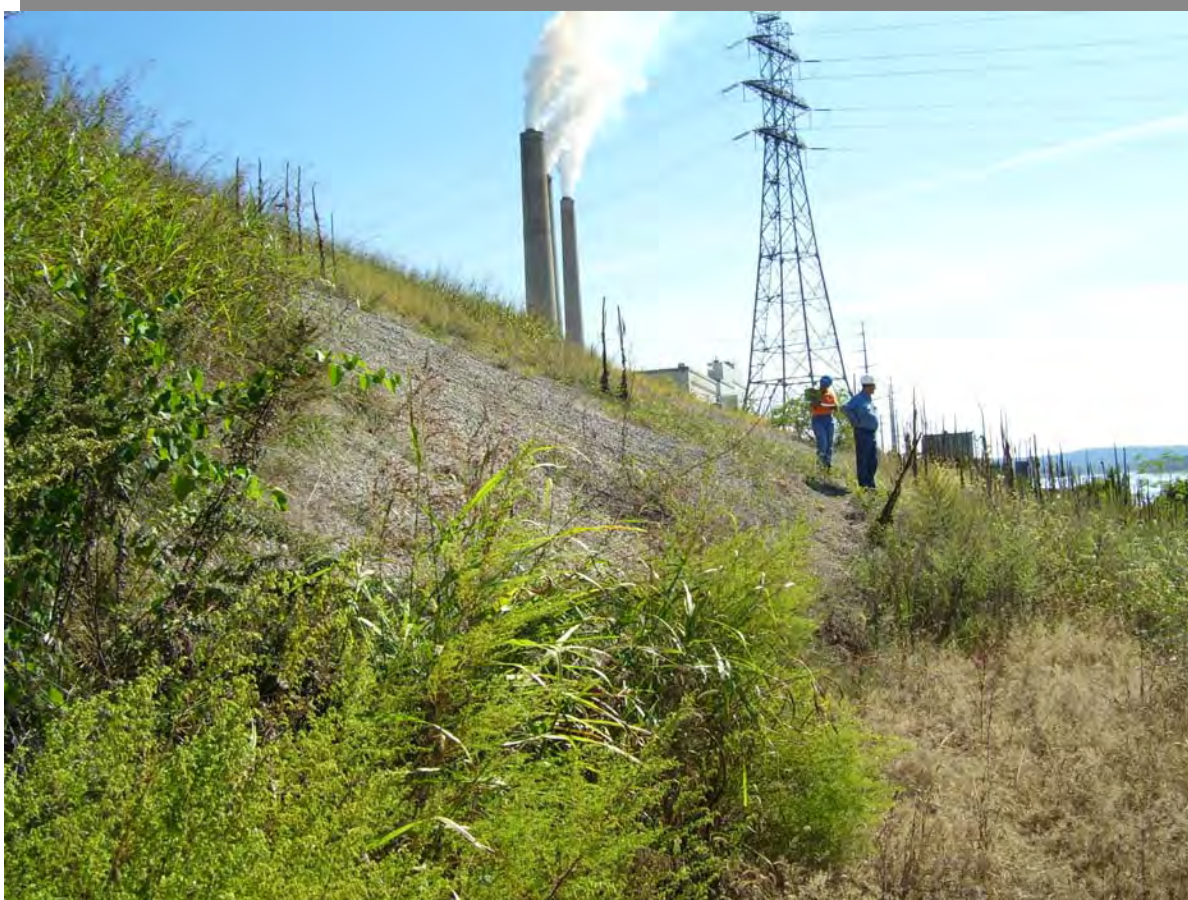
Photo 15 – Gravel blanket drain/slope failure repair area on western outboard slope.

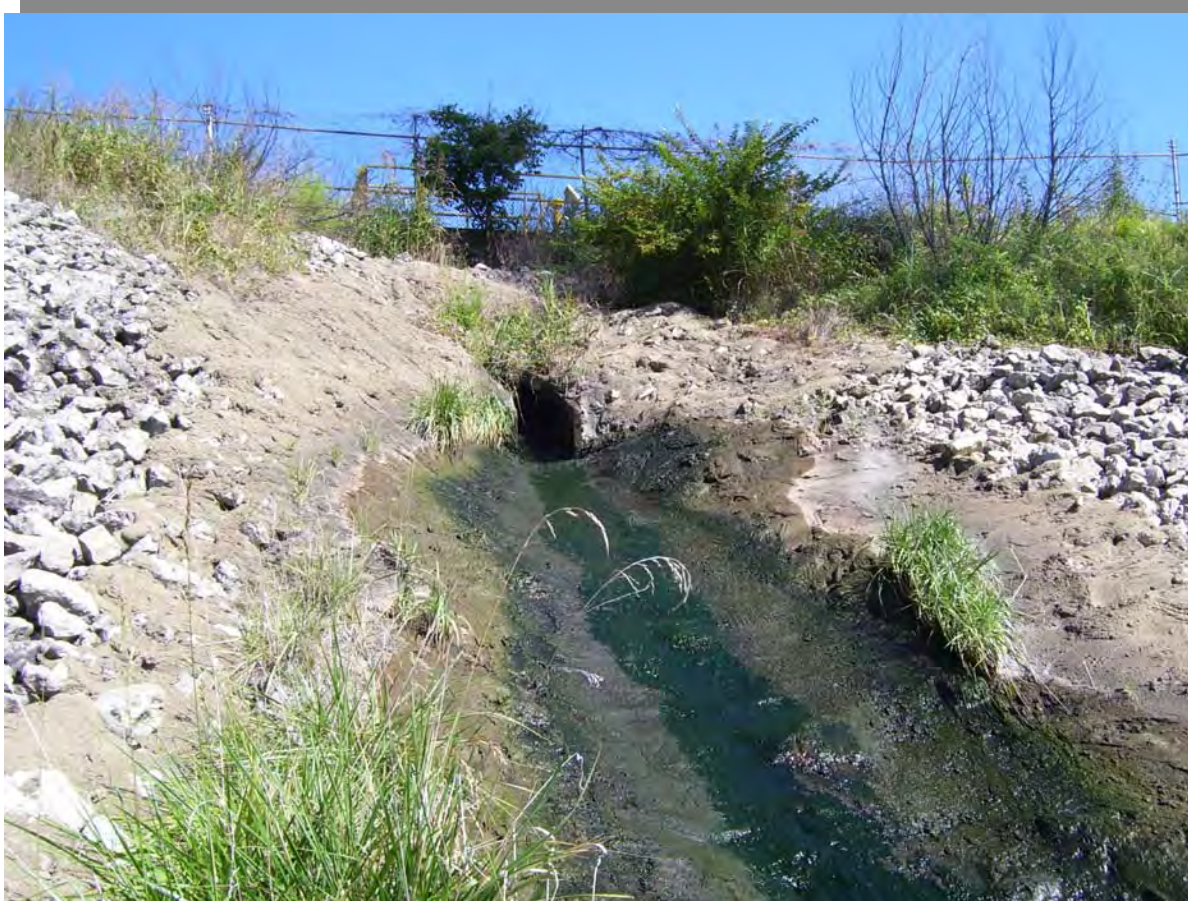
Photo 16 – Outlet flume and grouted riprap outlet channel looking upstream.
